Report Number: 214-TRC-03-009

Safety Compliance Testing For FMVSS 214

Side Impact Protection

**Bayerische Motorenwerke AG
2003 BMW 325i 4-door Sedan**

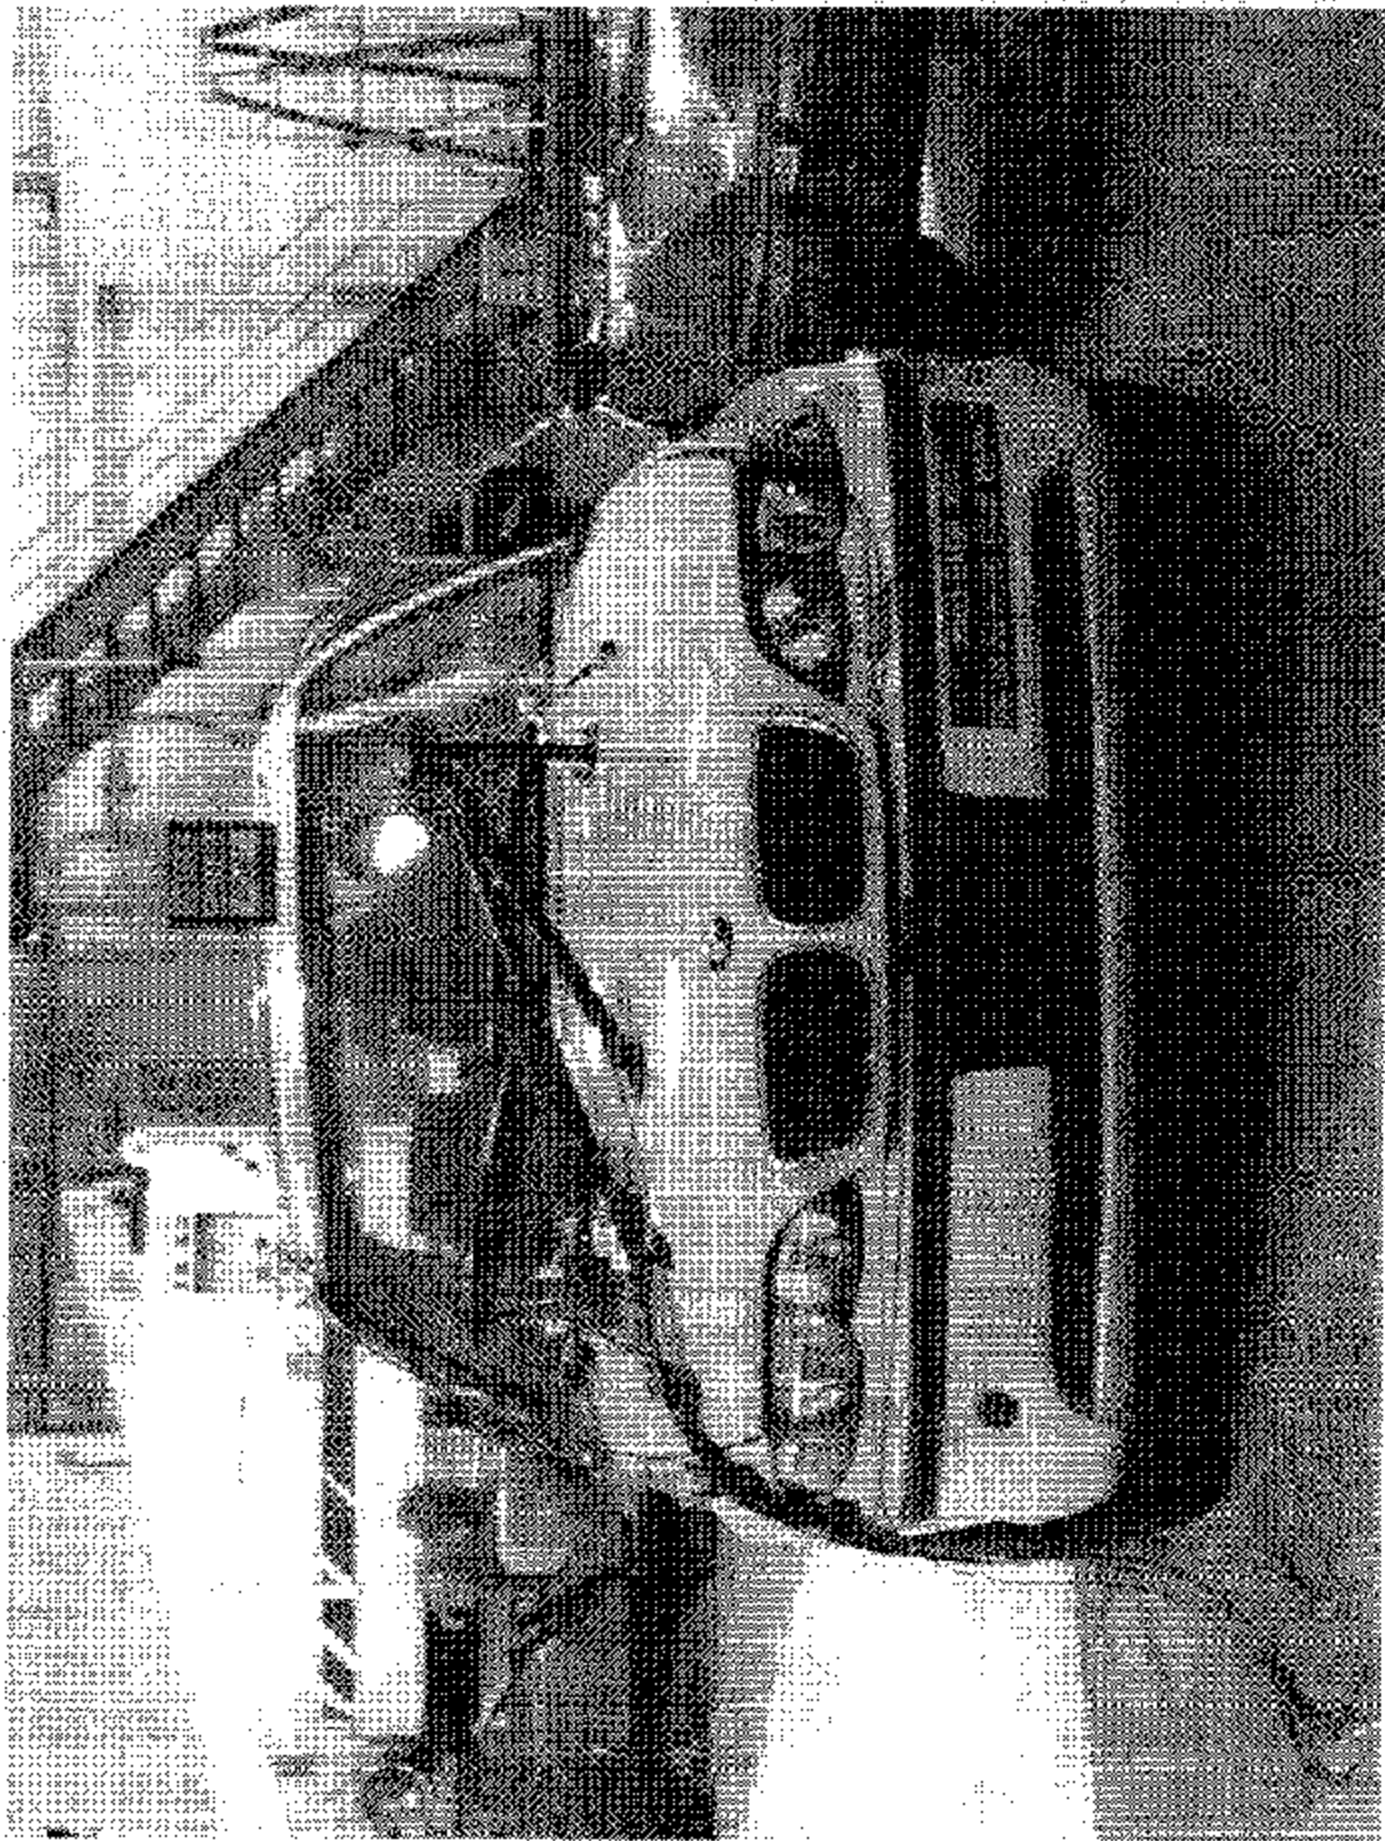
Figure A-2 Post-Test Front View of Test Vehicle

Windshield:	<u>Broken along driver A-pillar</u>
Window:	<u>Driver and passenger side windows broken.</u>

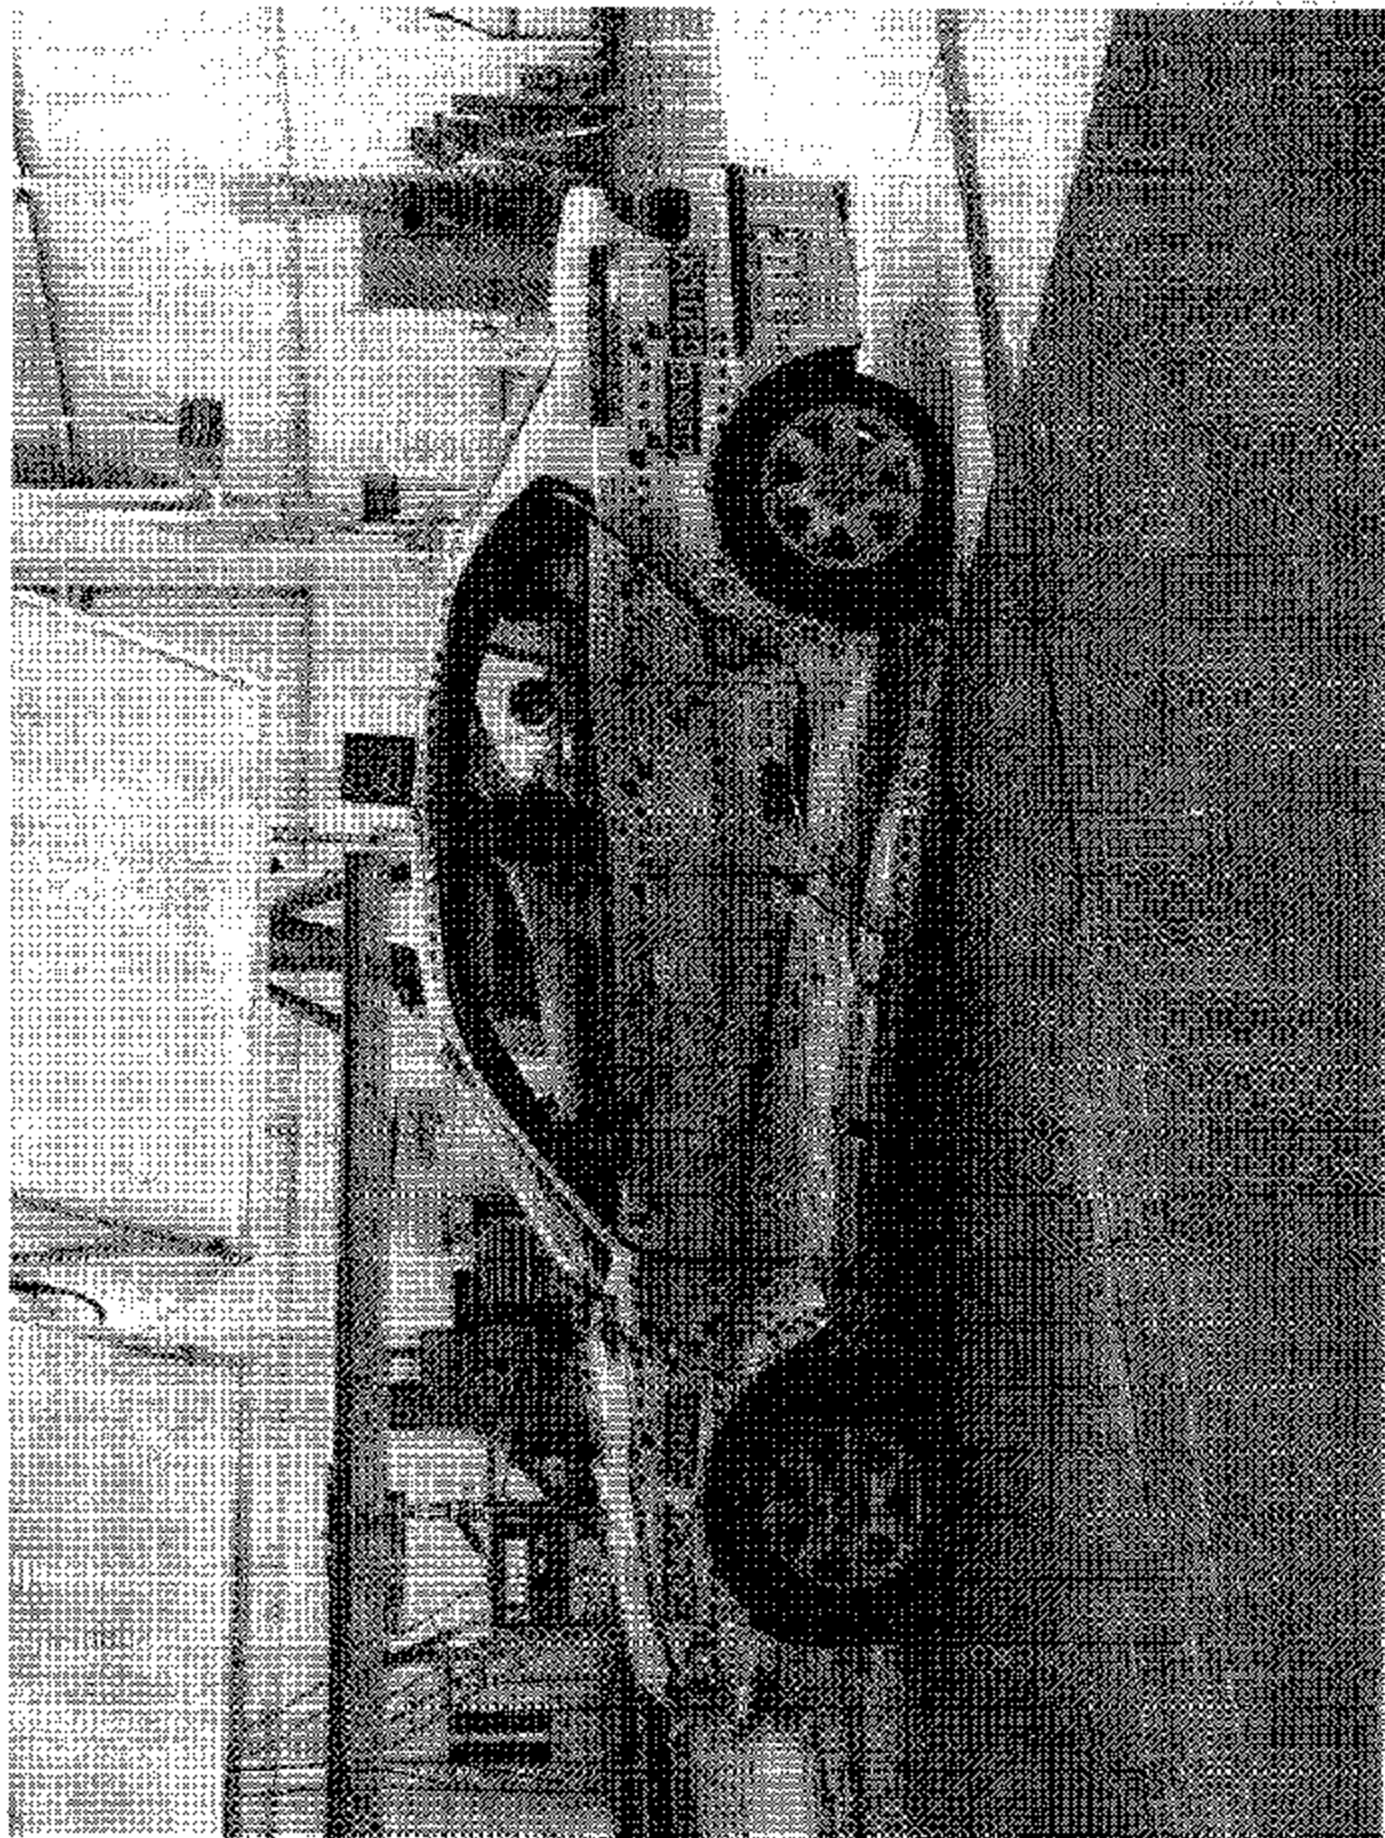
Figure A-4 Post-Test Impacted Side View of Test Vehicle

<p>The two doors on the struck side of the vehicle did not separate from the body at the hinges or latches and the opposite doors did not open during side impact event.</p>				Front SID-H3		Rear SID-H3		Left Upper Rib Acceleration:	58.8	g's	49.7	g's	Left Lower Rib Acceleration:	51.5	g's	52.3	g's	Lower Spine Acceleration:	94.4	g's	47.6	g's	Thoracic Trauma Index, (TTI):	76.6	g's	50.0	g's	Pelvis Acceleration (PEV):	130.3	g's	55.9	g's
	Front SID-H3		Rear SID-H3																													
Left Upper Rib Acceleration:	58.8	g's	49.7	g's																												
Left Lower Rib Acceleration:	51.5	g's	52.3	g's																												
Lower Spine Acceleration:	94.4	g's	47.6	g's																												
Thoracic Trauma Index, (TTI):	76.6	g's	50.0	g's																												
Pelvis Acceleration (PEV):	130.3	g's	55.9	g's																												
17. Key Words Compliance Testing Side Impact Protection FMVSS 214 Side Impact Dummy (SID III)	18. Distribution Statement Copies of this report are available from: NHTSA Technical Information Services (TIS) Room 5108 (NPO-230), 400 Seventh Street, S.W. Washington, DC 20590 Telephone No. (202) 366-4946 Attn: Robert Hornicle																															
19. Security Classification (of this report) Unclassified	20. Security Classification (of this page) Unclassified	21. Number of Pages 428																														
		22. Price
